Service Bulletin

Bulletin No: 23 002 04 (025)

BMW Motorrad USA

Topic: Ball End Working Loose on Gearshift Lever.
F 650 CS

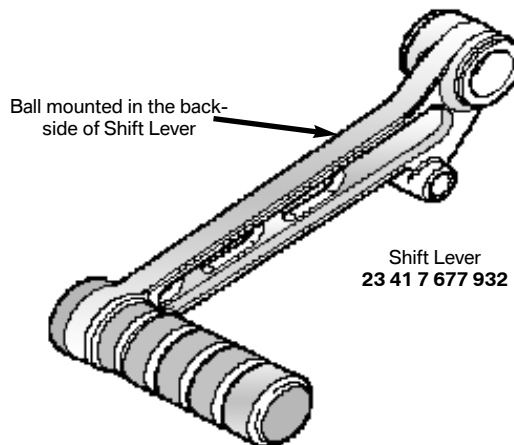
Picture 1

Subject: The ball end mounted on the inside of the gearshift lever can work loose. In the worst case this may cause the gearbox to shift with difficulty, or not at all.

- Service:**
- 1: Check the security of the ball end on the shift lever.
 - 2: If the threaded ball end is found to have worked loose on the shift lever, remove the entire shift lever and install the modified shift lever with reworked ball end.
