Service Bulletin

Bulletin No: 34 003 01 (034) Revised

BMW Motorcycles

Subject: Technical Hold - F 650 GS/Dakar rear speed sensor mounting point/wheel cover modification.

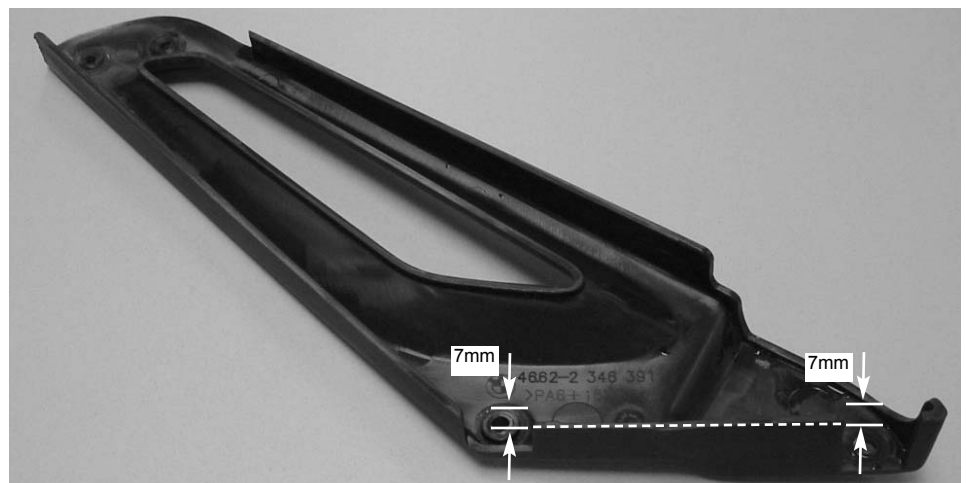
Details: In series production, the speed sensor at the rear wheel was changed from a type DF10 to a type DF11. The speed sensor type DF11 uses a mounting flange that is both wider and higher than that used with the type DF10 sensor. This change in the dimensions of the mounting flange could lead to the interference of the speed sensor with the speed sensor ring when the left side wheel cover (P/N 46 62 2 346 391) is installed.

Aftersales Solution: The rear wheel cover, (P/N 46 62 2 346 391), is to be modified on all motorcycles within the affected VIN range. This modification involves trimming the bottom left hand corner of the cover, to provide clearance necessary for the use of the new speed sensor/mounting bracket combination (see attached photo).

- 1) Remove the left side rear wheel cover (P/N 46 62 2 346 391).
- 2) Using a marker or a scribe, mark a 7mm wide section on the rear cover. (see picture)
- 3) Using an appropriate cutting tool, remove the 7mm section of the rear wheel cover. Use a file, or suitable finishing tool, to finish the cut edge as necessary.
- 4) Reinstall the left side rear wheel cover.
